**WASTE MANAGEMENT DIVISION
RCRA ENFORCEMENT OFFICE
RCRA COMPLIANCE EVALUATION INSPECTION REPORT**

Purpose: RCRA Compliance Evaluation Inspection

Facility: Exide Technologies

Date of Inspection: July 22, 2008

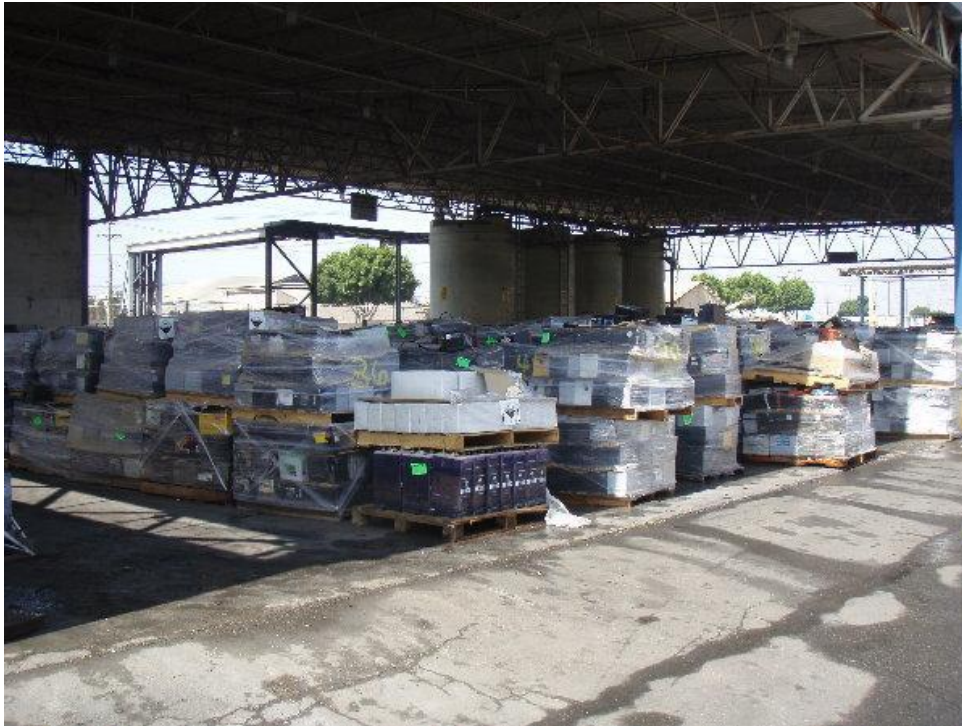
Location	Container Type	Waste Type	Potential Violation
Accepted Raw Material Staging Area	Approximately 225 pallets of SLABs (Photo 1)	SLABs received and accepted by Exide are stored here awaiting processing in the smelter	None
Southwest Corner of Storage Building	4 – 9,000-gal settling tanks	All storm water and dust suppression water is pumped to these tanks. Solids and liquids are pumped to the wastewater treatment unit for processing.	None
Storm Water Retention Pond (south of storage building)	2.8 million gallon pond	Empty and no longer receiving facility run-off.	None
Asphalt in front of building (Photo 2)	NA	The areas between the buildings are covered in asphalt	Area of Concern – The asphalt has a number of cracks that could be pathways for lead migration into the underlying soil.

Photo 1 – SLABs in Central Container Storage Building

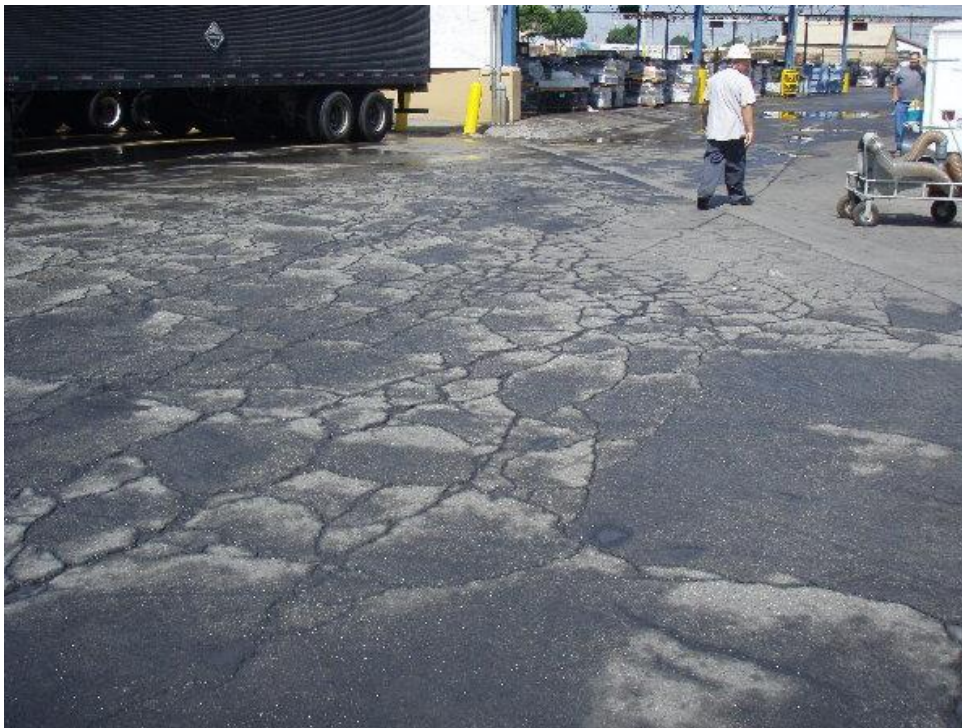
Photo 2 – Cracked asphalt paving between buildings

The areas between the buildings are covered in asphalt (Photo 2). The asphalt has a number of cracks that could be pathways for lead migration into the underlying soil. The facility conducts regular water spraying of the asphalted areas to control dust, which may contain lead; the area is then cleaned with a street sweeper. The water from dust suppression is collected in the street sweeper and transferred to the wastewater treatment unit. The facility repairs obvious asphalt cracks, but capital expenditures are focused on maintenance of the building's concrete floors because these floors are in close or direct contact with the lead and acid from the SLABs.

According to the facility representatives, the floors of the buildings are ten-inch-thick concrete. Exide conducted maintenance on the smelter floor in June 2008. They have repairs and recoating scheduled for the third quarter of 2008 on the floor of the RMPS battery cracking area. In the fourth quarter of 2008, Exide is scheduled to repair and/or replace the floors in the wastewater treatment area and the mud tank row area.

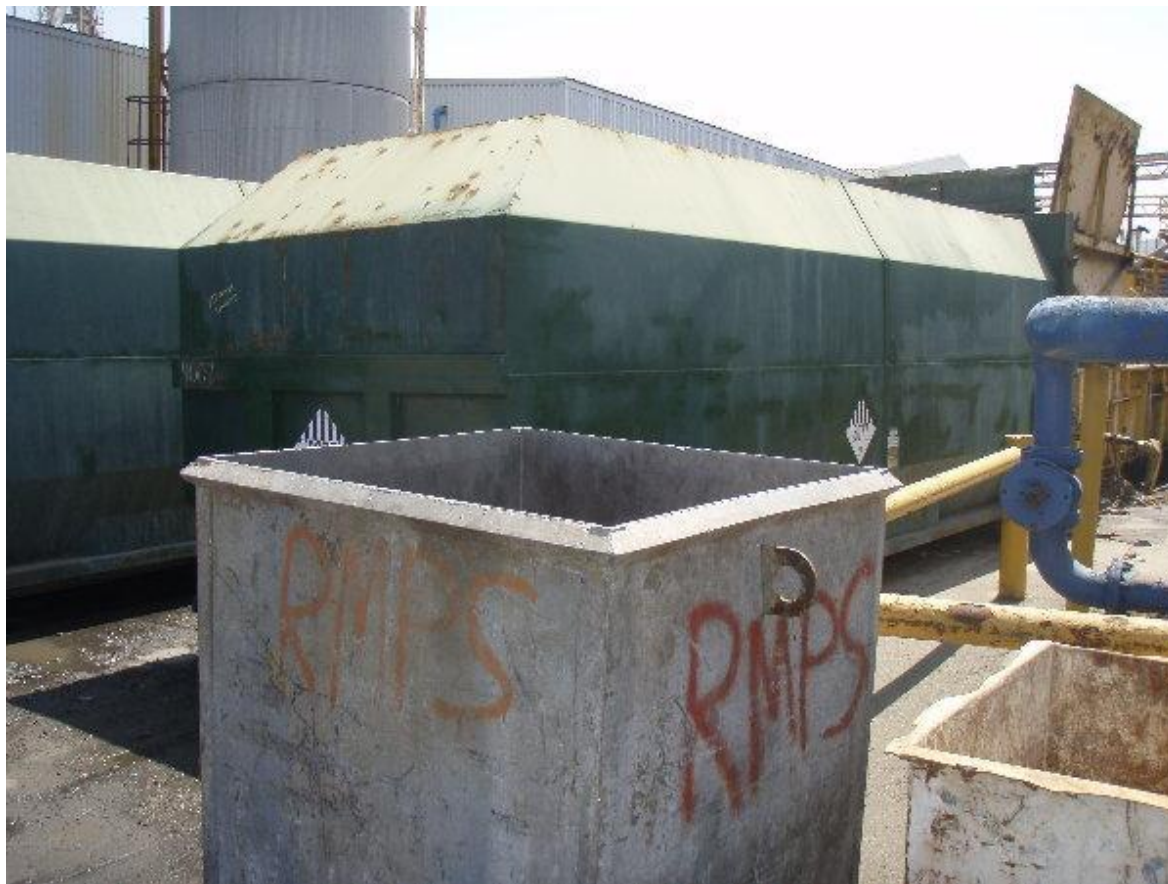
Location	Container Type	Waste Type	Potential Violation
Outside of southwest corner of RMPS Building	1 – 40-cubic yard roll-off bin (Photo 3)	Lead debris (D008)	Unlabeled container
Southwest entrance to RMPS Building	NA	Battery cracking – lead, acid, and plastic separated for processing	None
Reverbatory Furnace Feed Room	NA	Lead sludge from wastewater treatment unit is stored in this room and is sent by conveyor belt through a furnace to reduce moisture to about 14% before being fed into reverberatory furnace	None

Photo 3 – Unlabeled 40-cubic-yard roll-off bin of lead debris (D008)

Outside the southwest corner of the RMPS Building was a 40-cubic-yard roll-off bin containing lead debris that was unlabeled. The facility representative indicated that the roll-off bin is filled and shipped off site once to twice a week and that the bin is labeled prior to transporting off site. The inspector explained to the facility representative the requirement for a hazardous waste label to be on the bin when waste accumulation begins in the bin.

Two weeks after the inspection, Exide provided a photograph documenting that the roll-off bin is now properly labeled.

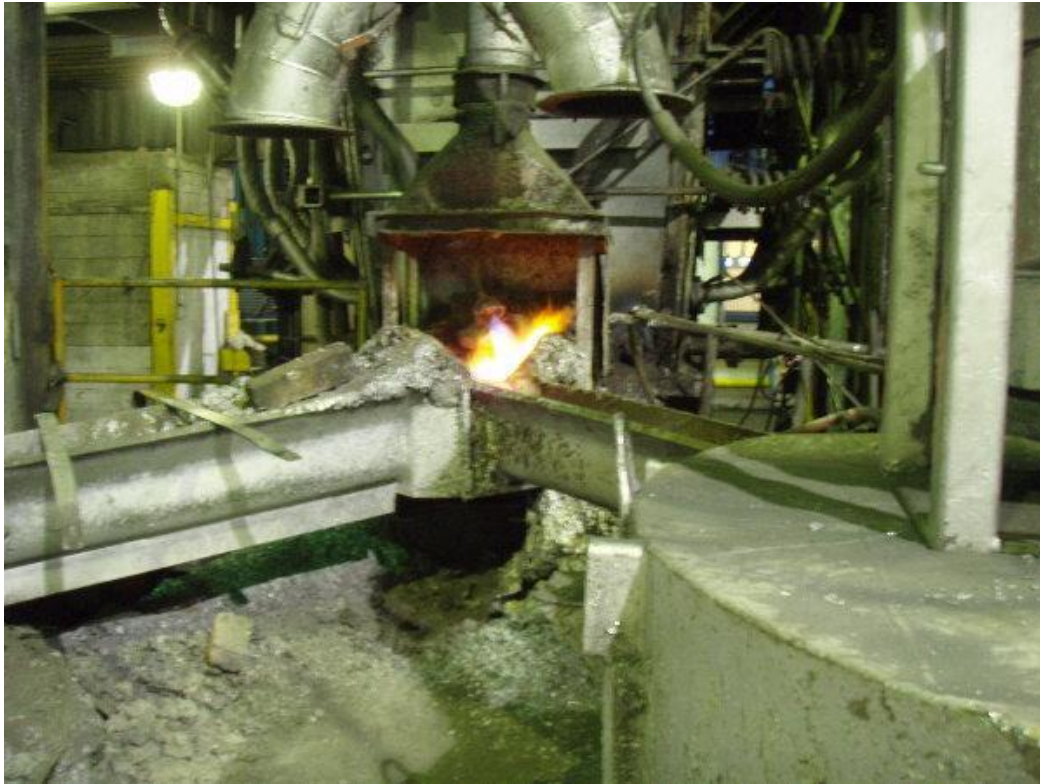
Location	Container Type	Waste Type	Potential Violation
Reverberatory Furnace	NA	Lead and lead oxide is fed to reverberatory furnace to recover lead	
Blast Furnace	NA	Slag from reverberatory furnace is fed to blast furnace for lead recovery. Slag from blast furnace is fed back through furnace until enough lead has been recovered so that the slag is no longer hazardous. (Photos 4 and 5)	None

Photo 4 – Molten lead from blast furnace

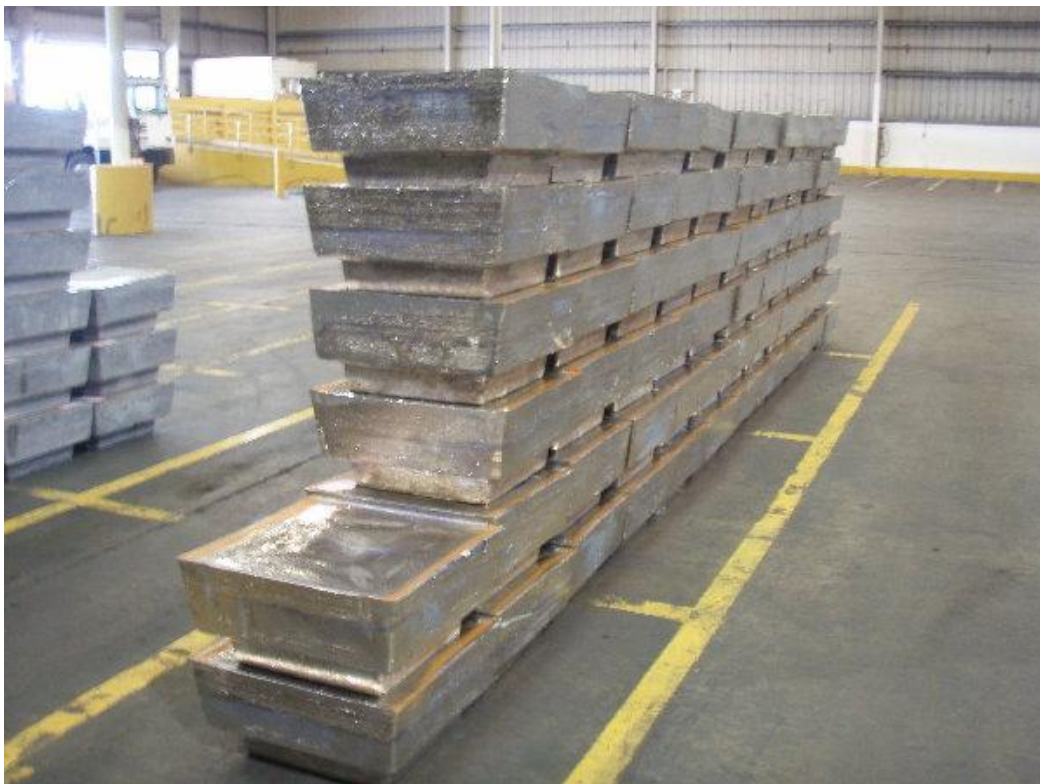
Photo 5 – Stack of finished product: 2,000 pound blocks of lead
